Case report

Disengagement of tibial insert locking pin in total knee arthroplasty - A rare failure case report

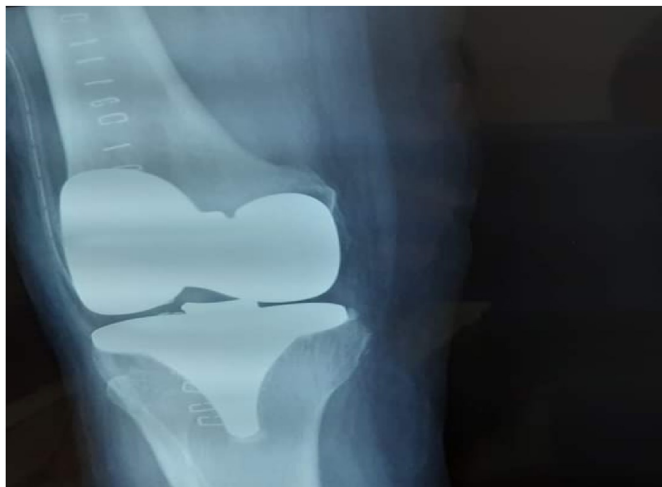
Fig. 1. Immediate post operative X-rays.

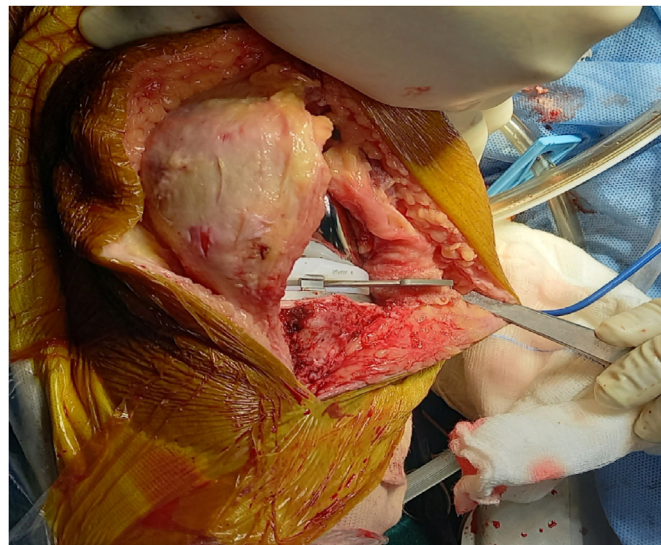
Fig. 3. Intra operative picture showing medial migration of pin.

subluxation or dislocation but only locking mechanism failed and pin migrated to medial side.

In our case there was no fall or trauma. Intra operatively there were no macroscopic signs of damage to locking pin or insert. Possibility of soft tissue interposition between locking pin and insert seems to be rare as surgeon ensures to retract all soft tissue away during pin placement in every case. Exact cause of locking pin failure could not be ascertained.

There was no soft tissue impingement between insert and tibia component, but insert was removed and exchanged precautionary. Pin was also removed and exchanged. Intra operative Fluid and tissue sample was taken for culture and sensitivity testing. Check x-rays was done next day for confirmation of new locking pin position (see Fig. 3). Post Operative period was uneventful. Cultures were sterile. Patient is currently under follow up and is doing well. Implant company representative was contacted and extracted implant was shown but according to company there was no defect in insert locking function. So company was not sure of the reason for this complication (see Fig. 4).

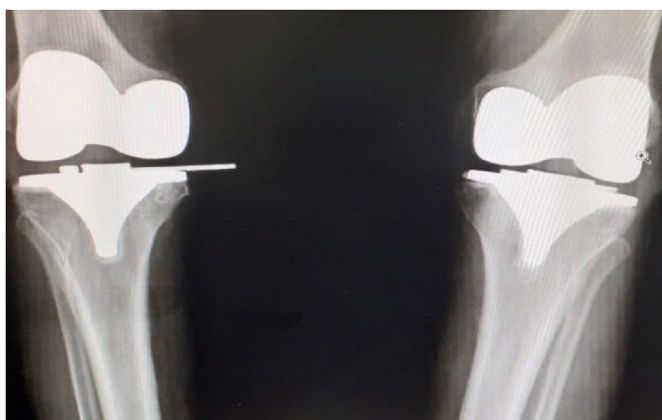
A 62 year old female patient was diagnosed with Degenerative Osteoarthritis both Knee. Patient was planned for Total Knee Arthroplasty and was operated in single sitting in April 2019. The procedure was uneventful. The patient was allowed weight bearing next day with support and physiotherapy was started. Patient was discharged after 5 days under satisfactory condition. Rehabilitation process was also uneventful and patient achieved full knee range of motion. After 8 months of index surgery patient had pain on medial side of right knee. Patient had no history of trauma to the knee. On examination patient had complete range of motion but had swelling over medial side of right knee. X-rays showed disengagement of locking pin of insert from tibia component (see Fig. 1). Routine blood investigations were normal. Inflammatory parameters were also normal. Patient was planned for arthrotomy and exchange of locking pin. Routine midline skin incision was given and joint was opened. Locking pin was found to be disengaged and lying free on medial side after piercing soft tissue (see Fig. 2). Femur and Tibia components and polyethylene insert were well fixed.

Fig. 2. X-rays showing disengagement of locking pin of right knee.

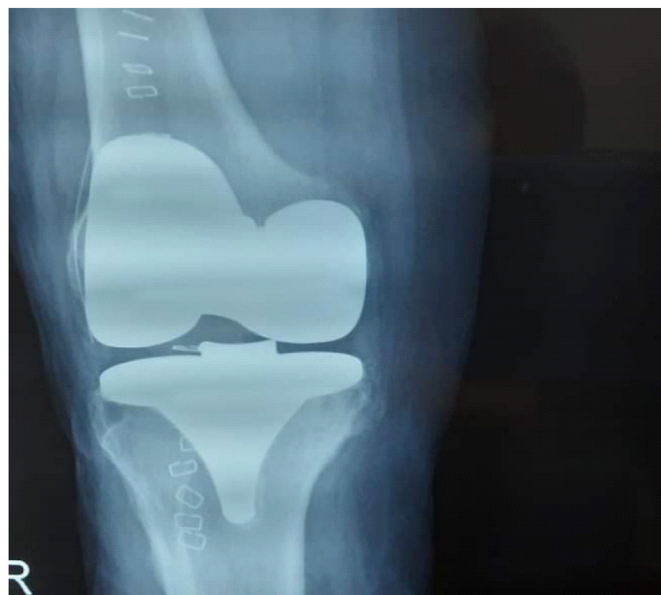
Fig. 4. Post operative x-rays showing correct pin placement.
